ANALYSIS OF SERVICE OF REFRACTORIES IN GLASS-MELTING TANK FURNACES

V. D. Tokarev,¹ S. S. Igat'ev¹, and O. N. Popov¹Translated from *Steklo i Keramika*, No. 5, pp. 19 – 22, May, 2006.

The fundamental issues of extending the period between repairs for glass-melting tank furnaces are analyzed. Based on data obtained in studying refractory brickwork after the furnace has been stopped for a cold repair and analyzing the specifics of corrosion of refractories in various structural elements, technical solutions are proposed and implemented enabling one to extend the tank furnace campaign to 7 – 8 years.

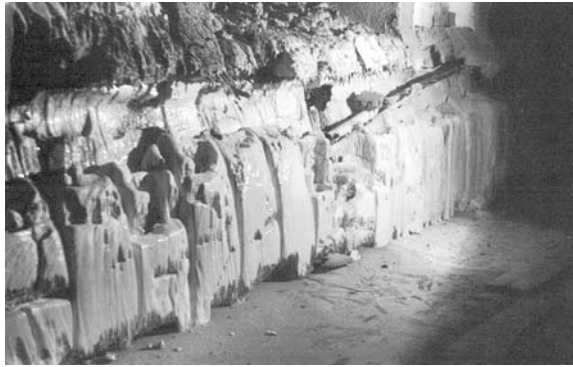
Melting tank walls. This element of brickwork for a long period was the main element limiting the campaign duration. The corrosion of the melting tank walls at the level of the glass melt surface in the contact site of three different phases used to lead to a complete wear of this part (Fig. 1).

Statistic processing of furnace inspection data established that the main factors responsible for the corrosion of melted-cast baddeleyite-corundum (bacor) refractories on the specified sites are the maximum glass-melting temperatures

Fig. 1. Melting tank wall after the furnace was closed for cold repair.

The analysis of obtained dependences demonstrates that the maximum melting temperature t_m has a significantly greater effect on the rate of the wall corrosion at the glass melt level expressed via the time τ of reaching the residual thickness of 30 mm than the specific melt output G . Thus, raising t_m by 50°C (from 1550 to 1600°C) with $G = 1500 - 2000 \text{ kg/m}^2$ per day shortens the time of reaching the residual thickness of 30 mm by 30–35%, whereas an increase in G by 500 kg/m^3 per day (from 1500 to 2000) at $t_m = 1550 - 1600^\circ\text{C}$ decreases it by only 7–9%. Evidently, the effect of the kinetic factors on accelerating the corrosion process has more weight than the mechanical factors, considering the low velocity of glass melt near the walls of the melting tank wall (up to 10 m/h). Note that the insignificant effect of glass melt flows on the destruction of the melting tank walls is noted in the classical work of Prof. N. V. Solomin.

The dependence shown in Fig. 2 makes it possible to justify the time of installing additional plates on the melting tank wall at the glass melt level, which is currently considered the most efficient solution extending the service life of this brickwork element. Thus, in a furnace with $t_m = 1550^\circ\text{C}$ and $G = 1500 \text{ kg/m}^2$ per day using domestic refractory bacor 33, new plates have to be installed after 33–39 months of service, whereas in a furnace with $t_m = 1600^\circ\text{C}$ and $G = 2000 \text{ kg/m}^2$ per day new plates have to be installed after 26–28 months. Note that the use of more resistant refractory materials or more intense forced air cooling may significantly extend the initial period of failure-free service of this brickwork element up to the first installment of additional plates.

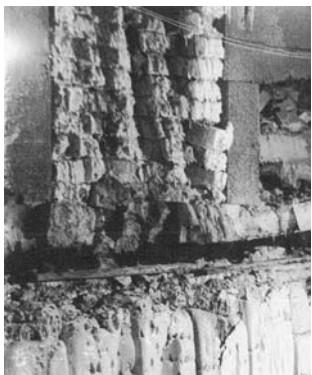
The destruction of dinas parts of brickwork elements (Fig. 3) under the effect of aggressive volatile batch components, especially alkali components was sufficiently intense and manifested in fusion of surface sites, which required frequent hot repairs, sometimes with a total replacement of

Fig. 3. Destruction of dinas brickwork elements of the melting part of the furnace.

some elements, for instance, the burner cheeks and stringers in the melting and maximum temperature zones.

The chemical analysis of dinas samples from the flame space walls and burners indicated the presence of up to 2.5 – 4.0% Na_2O . However, according to the data in [4], the content of 3 – 4% Na_2O in dinas decreases its softening temperature to 1550°C and 5 – 6% Na_2O decreases it to 1450°C. The additional direct impact of the flame on the surface of the specified refractory elements produces local superheating up to temperatures frequently exceeding the maximum melting temperature. Therefore, the use of dinas in the brickwork of burners and walls of the flame space is not advisable. To improve the service reliability of these elements and extend the furnace campaign, they have to be constructed from more resistant bacor refractories.

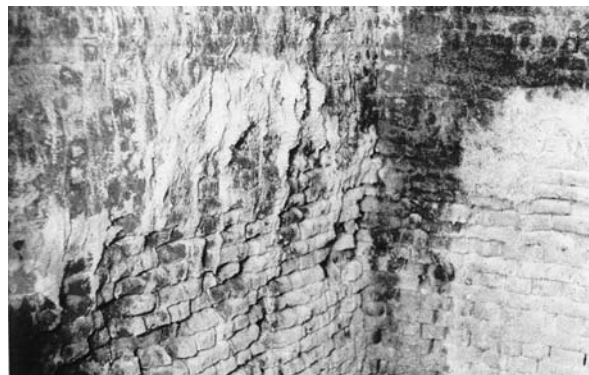
Fig. 4. The state of regenerator elements in the end of the furnace campaign.

It should be noted that the reasons for the fast destruction of dinas refractory elements are the same as in the case of the burners and flame space walls. Naturally this process is further accelerated by the periodic (every 20 – 30 min) flame reversal, which periodically creates a significant temperature difference (up to 300 – 400°C) within a very short time. Under such conditions not only dinas, but magnesian refractories as well, experience intense corrosion (Fig. 4).

A positive effect on decreasing the rate of corrosion of regenerator chamber roofs can be obtained by raising the roof with respect to the checkerwork and introducing an additional row of beams above the inlets and the walls between the burners.

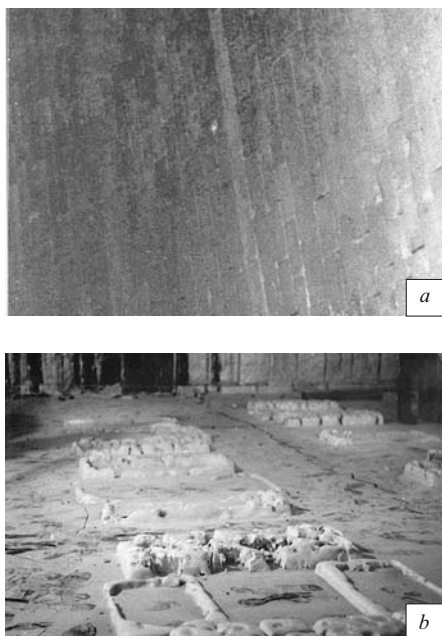
Fig. 5. The inner surface of the main roof (a) and the bottom of the melting tank (b) after the furnace was closed for cold repair.

At our company the main roof of tank furnaces made of glass dinas and open-hearth dinas from the Dinur Works (Pervouralsk) has served well throughout the campaign (over 7 years) and actually did not experience significant corrosion (Fig. 5a). We have registered only slight fusion in the first and the second sections with brickwork thickness decreasing by 5 – 10 mm, whereas in the remaining sections the inner roof surface actually did not undergo any thermal or structural changes.

In our opinion, such situation of the dinas main roof is due to high-quality sealing and heat insulation of its outer surface, using the classical variant including a zircon-phosphate sealing paste, quartz sand, dinas lightweight brick, mullite-silica fibers, and polished aluminum sheets. Note that insulation and especially thorough sealing of joints actually prevents the corrosion of dinas brickwork in the roof.

As for the bottom of the melting tank, we have developed and implemented a multilayer heat-insulated tank bottom, which has that has high service reliability and makes it possible to level the glass melt temperature gradient across the tank depth with significant saving of fuel (2 – 5%) and improving the chemical and thermal homogeneity of the glass melt. The only difficulty in the service of the tank bottom is installing nozzles for glass melt swirling; however, for this purpose we have developed and implemented a special bubbling unit ensuring high service reliability of this brickwork element (Fig. 5b).
